# The Challenge Machinery Company

## PRODUCT SAFETY BULLETIN

**Product:** 370 X cutter

**Description:** Notch in Clevis may not be deep enough

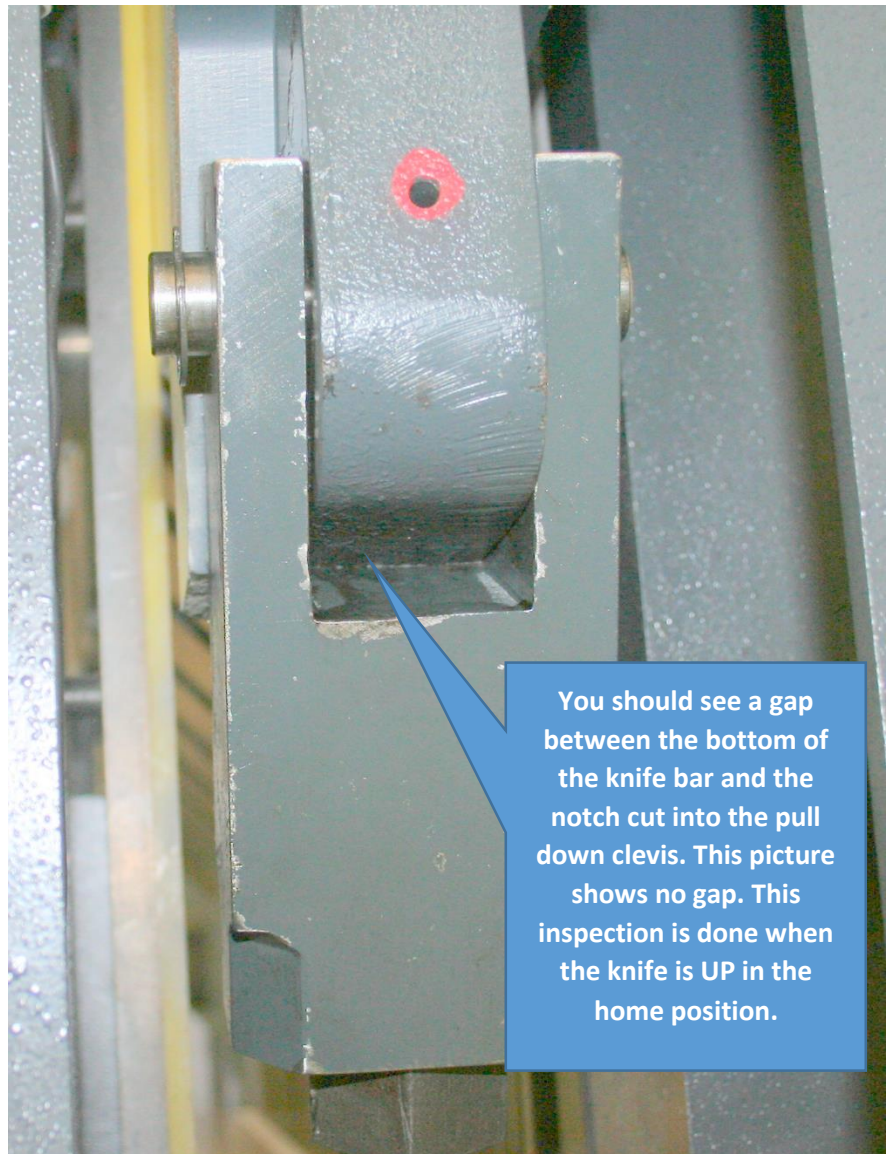
This inspection should be done when the knife is in the up position and the power to the machine turned OFF. You should see a gap between the notch cut in the knife pull down clevis and the knife bar casting. See photo, in this photo there is no gap. If your machine does not have a gap at this location contact Challenge Machinery for a replacement clevis.

You should see a gap between the bottom of the knife bar and the notch cut into the pull down clevis. This picture shows no gap. This inspection is done when the knife is UP in the home position.
